Manhole Inspection Summary

Manhole # S39II_005MH

Insp Date: **6/8/09 9:04 AM**

Location Address: **1647 AISQUITH ST**

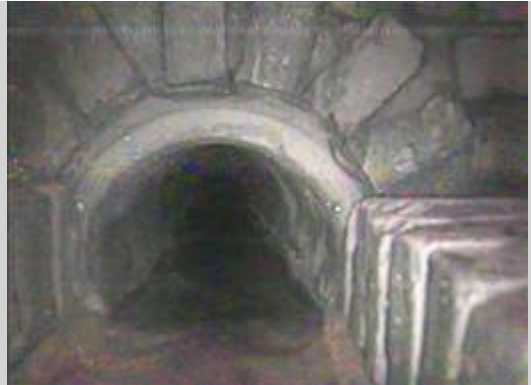
12 O'Clock Outflow

8 in. Circular Gravity Sewer
Pipe Out @ 12 O'Clock

Pipe Material: **Clay** ☐ Pipe Lined

Invert Depth: **15.66** (ft.) Flow Characteristics: **Slow**

Infiltration: **None** Pipe Seal Cond: **Sound**

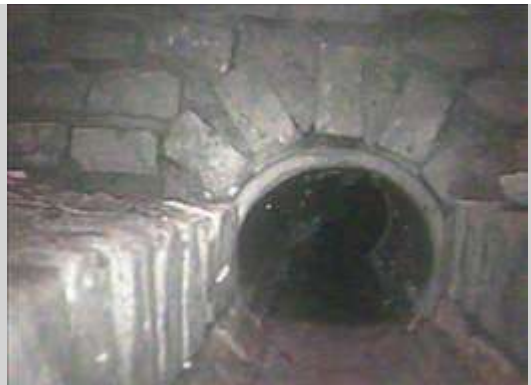
6 O'Clock Inflow

8 in. Circular Gravity Sewer
Pipe In @ 6 O'Clock

Pipe Material: **Clay** ☐ Pipe Lined

Invert Depth: **13.64** (ft.) Flow Characteristics: **Slow**

Infiltration: **None** Pipe Seal Cond: **Sound**

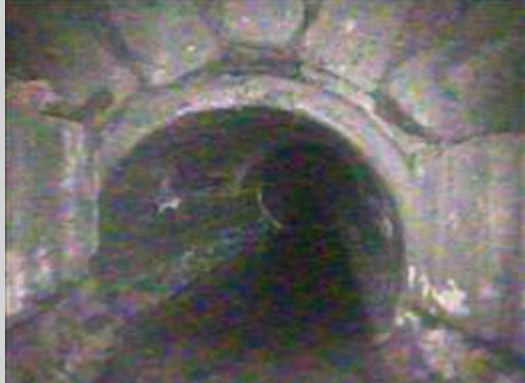
9 O'Clock Inflow

8 in. Circular Gravity Sewer

Pipe In @ 9 O'Clock

Pipe Material: **Clay** ☐ Pipe Lined

Infiltration: **None** Pipe Seal Cond: **Sound**
